# **Rockfall Hazard and Risk Assessment along Aizawl-Durtlang Road Section, Mizoram, India**

*Raghupratim Rakshit\* & Bubul Bharali\*\**

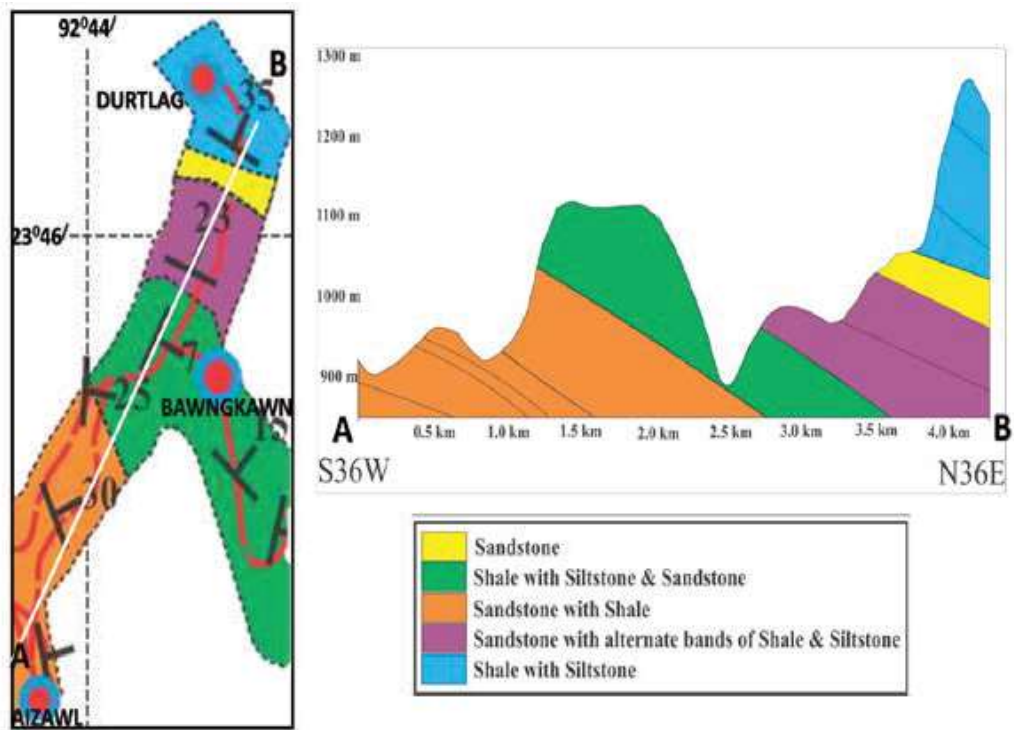
**Figure 2: Geological map and profile of the Aizawl-Durtlang road section.**

The geological map and cross section of the study area infers that the road section is comprised mainly of sandstone and shale dominated part, with some siltstone beds were also observed (Fig. 2). The dipping of the beds is mostly intermediate to high dip angle with slope towards western side of the ridge. The interbedded layers of the eastern part of the ridge comprise of the beds dipping in the same direction that with the topographic relief. This unstable bedding conditions results in failure along the slip surfaces (Rodgers and Tobin, 2014). Whereas in the western part as observed in our study, joints and fractures in the similar bedding conditions with greater topographic slope increase the possibilities of rock fall in the hard and compacted litho-units. The reason behind such fall is the wedge failure and toppled down due to adverse bedding situation. The Aizawl- Durtlang road section is subjected to this condition and therefore suffers more rockfall events than sliding along the planes. Further disturbances occurred in the slope condition due to various anthropogenic causes like excavation on the slope side, unplanned settlements, poor drainage system, deforestation, used water disposal and improper water supply and sewage systems enhanced the vulnerability (Chenkual, 2015). These lead to the weathering of the rocks and transforming them to soil and regolith. Soils formed in this way are loose sedimentary type, with high porosity and permeability in them. With high precipitation

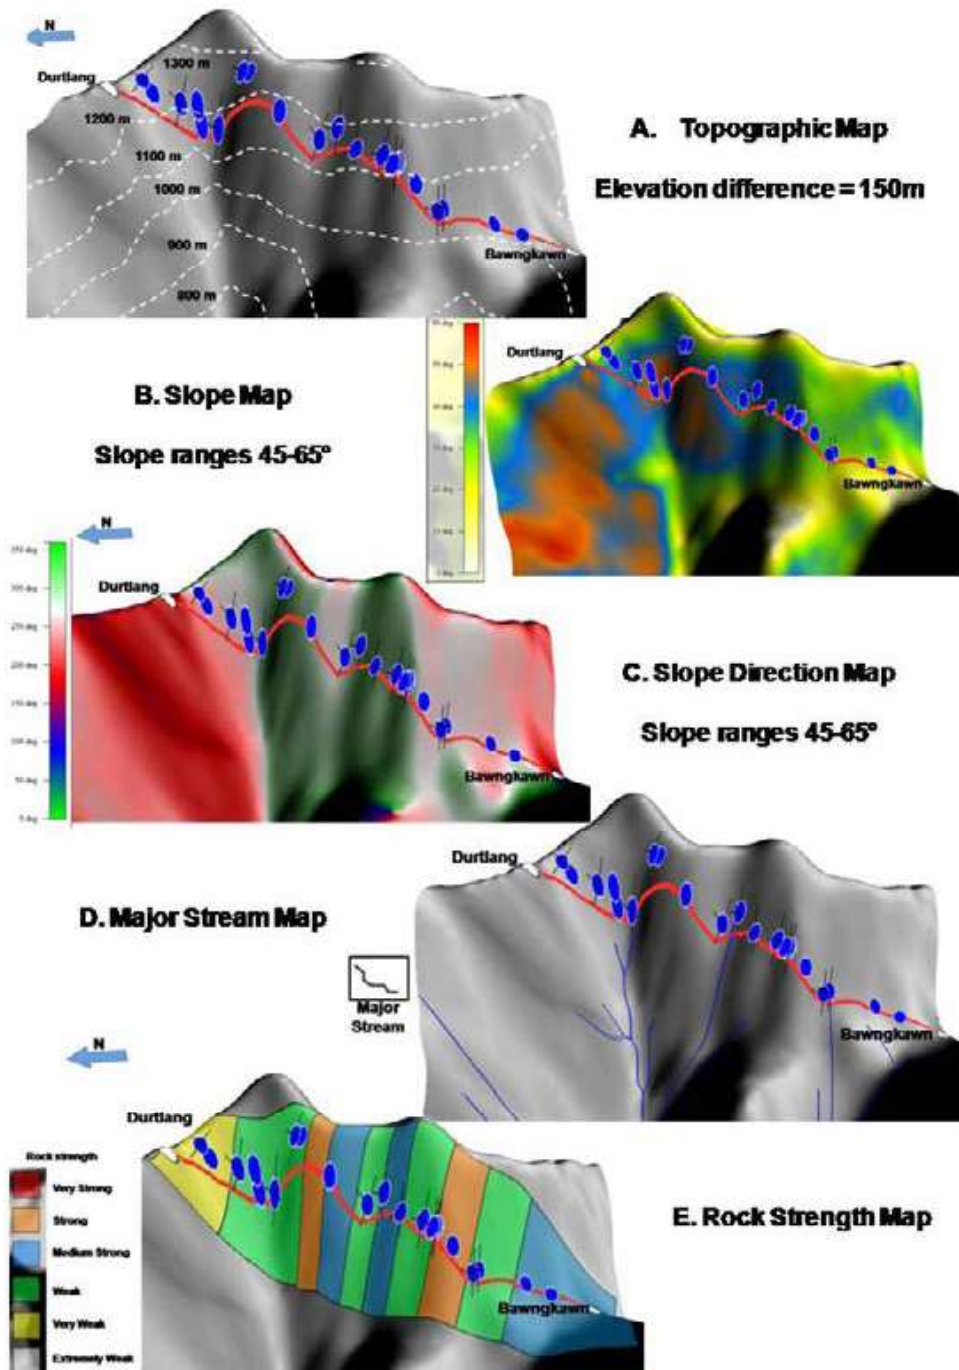
Figure 3: Different Thematic Maps for the Aizawl-Durtlang Road section. (Blue dots are some of the sample points along the bed attributes for that location).

To understand and assess the hazard condition in the road section, different thematic maps in GIS format are essential. These could only help to distinguish risk zone from the comparatively safer ones around real scenario. The average elevation differences in for the road is found to be around 150m (Fig. 3A). The topographic slope of  $65^{\circ}$  to  $75^{\circ}$ , as observed in the study area, could create more vulnerable situation to the already unstable condition (Fig. 3B). In such slope, average of 2.5m of soil were also observed during the field study. In some places, the loose soil is underlain by other soil type (blackish or reddish in colour) or rock beds were exposed (GID, 2007). The rock beds are mainly composed of sandstone and sandstone-siltstone association with shale beds are present in between. In other cases, shale dominating argillaceous facies also cause dismantling the arenaceous beds from the outcrop. In addition to that, slope direction also favours the sliding conditions along joint sets rather than the bedding surface (Fig. 3C). In this road section, the structural attributes are found to be similar as this part of the study area comprised the same ridge zone. The strike of the beds is from  $N30^{\circ}W-S30^{\circ}E$  to  $N40^{\circ}W-S40^{\circ}E$  with dip varies from  $12-38^{\circ}$  dipping towards  $20^{\circ}-30^{\circ}$  NE. The joint sets observed in some points of the study area have trends towards EW to  $N38^{\circ}W$ . The DEM has been used to identify the areas where the topographic slopes are geotechnically unfavourable due to water inflow along the major stream patterns (Fig 3D). The rock strength of different lithologies were measured semi-quantitatively using the in-situ geotechnical techniques. The rocks strength in the study area are in range from very weak to strong category (Fig. 3E). These make some localities easily

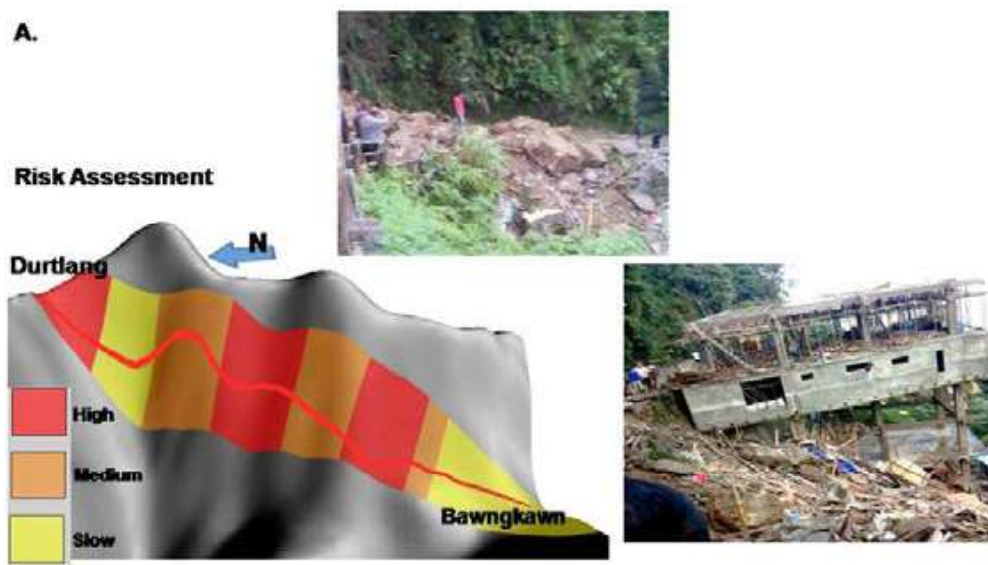
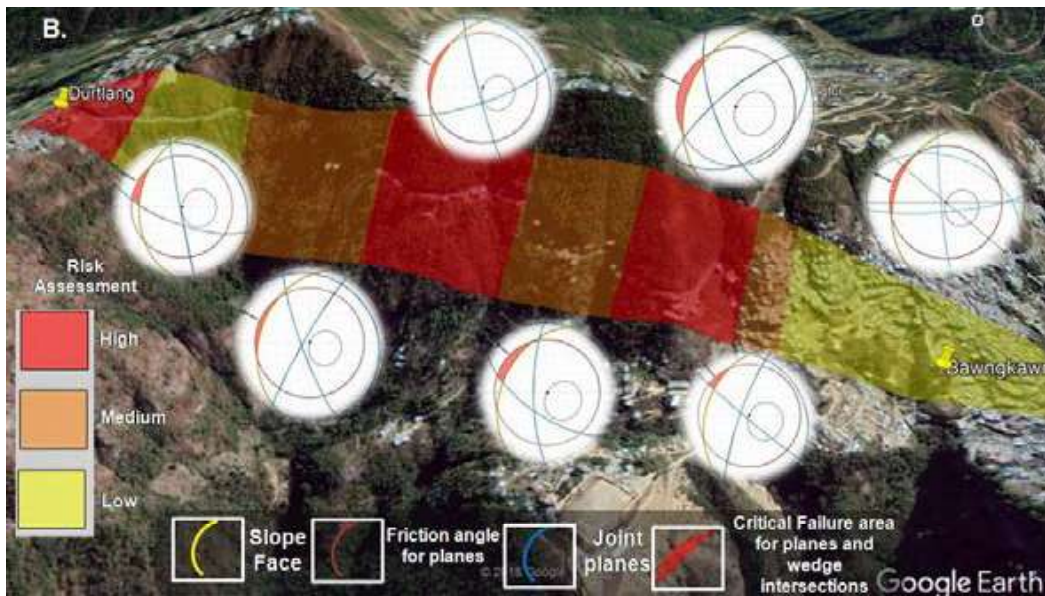
erodible and some might be favourable for rockfall. All the thematic maps can be associated in multilayer framework that ultimately provides us the risk assessment for the road section (Fig. 4). The stereoplots for the structural attributes indicate the potential wedge failure is high in most of the sandstone dominating section of the road, rather than shale dominating sectors. The joint sets and slope stability plot can be used to understand the rock fall hazard potential. The plot clearly indicates unfavourable bedding conditions in most parts of the study area which frequently failed to cause rockfall and slide events. Critical failure area for wedge failure is shown by the red zone in the stereoplots. The plots were incorporated into the Risk assessment layer to correlate with each other (Fig. 4B). This reveals that the area is subjected to medium to high risk zone.

characteristics of the rock beds. The bedding surfaces near Aizawl are much stable in such case and the risk increases towards half length of the section and then again show medium hazardous zone. The shale beds show higher frictional strength which left the arenaceous beds to topple down the slope. This study reveals that most part of the Aizawl Durtlang road section is vulnerable to rock fall cases and therefore authorities should take adequate measures to prevent any casualties from future events.
