Senhri Journal of Multidisciplinary Studies

DOI: 10.36110/sjms.2019.04.02.001

CASE STUDY OF COLLEGE VENG ROAD SECTION LANDSLIDE, AIZAWL, MIZORAM, INDIA

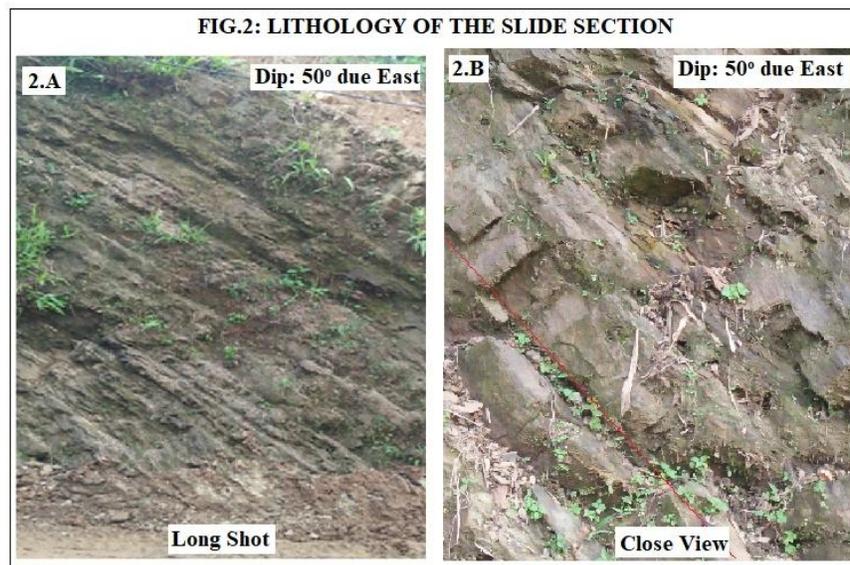
The lithology of the area of ‘College’ road section consists of Sandstone – Shale intercalation. The Sandstone layers are relatively thicker of the two, and the Shale layer is at the bottom (**Fig. 2A & 2B**).

It can be observed that the rocks dip uniformly due east, varies from 48° - 50° with an elevation of 3007 feet above mean sea level. At the base of the section, irregular and thinly bed of shales are visible.

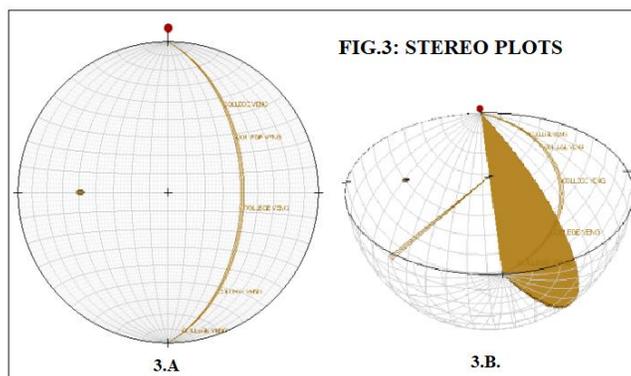
Both ‘2-D’ and ‘3-D’ stereo-plots clearly exhibit the easterly disposition of the rocks in the concerned section (**Fig. 3A & 3B**).

The similar disposition is confirmed by the “rose diagram” (**Fig. 4**). The exact direction of the slide, actually observed in

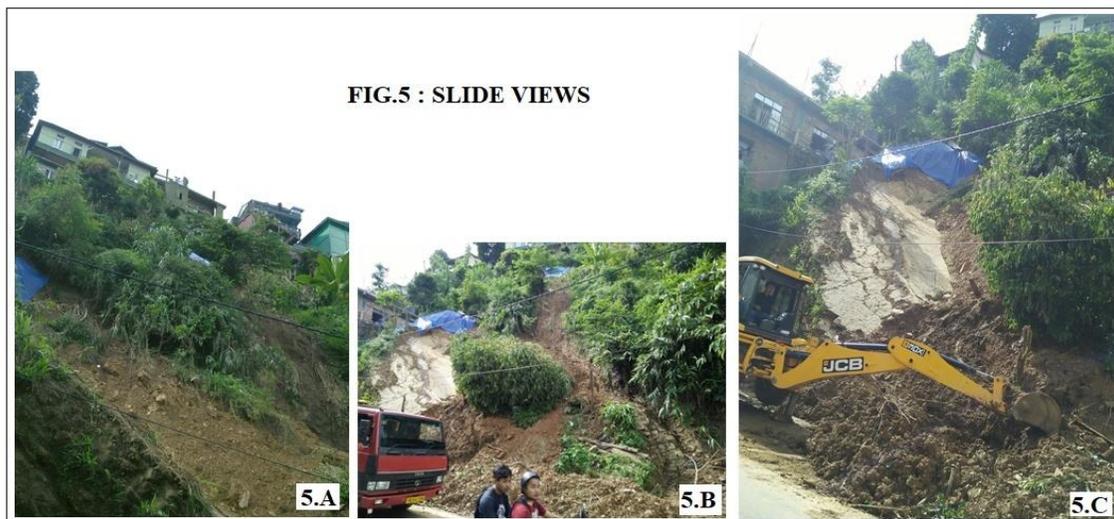
Since there are many houses on top of the slope (**Fig. 5A**), the combined overload of the buildings and the over wetting of the subsurface due to sewage, further aggravates the situation. Due to improper drainage of surface water runoff and poor sewage system, water percolates immediately through the top sandy soil and the whole area become water bearing horizon in the rainy season, which leads to the loosening of the Shale layer. By virtue of these factors, the higher parts of the slope above the water bearing horizon (top soil) become less stable and prone to subsidence and finally collapse in the dip direction, under the influence of gravitational force (**Fig. 5B & 5C**).

To avoid such incidences, situation demands immediate preventive measures such as meshing, filling and grouting, treatment of the discontinuities and improvement of in the drainage and sewage systems. Social counseling of people is also required to promote awareness about landslide hazard and demolition of high risk building and evacuation of urban population settlements at the top.
